SI 0078
For technical personnel only!
1/2

SERVICE INFORMATION

VACUUM PUMP DAMAGE DUE TO INCORRECT ASSIGNMENT

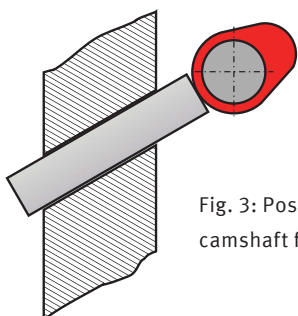
Fig. 3: Position of the camshaft for installation

In order to mount the pump with only a minimal amount of preload (max. 2 mm gap), the cam on the camshaft for driving the vacuum pump must be positioned on the opposite side of the connecting tappet (see Fig. 3) during mounting:

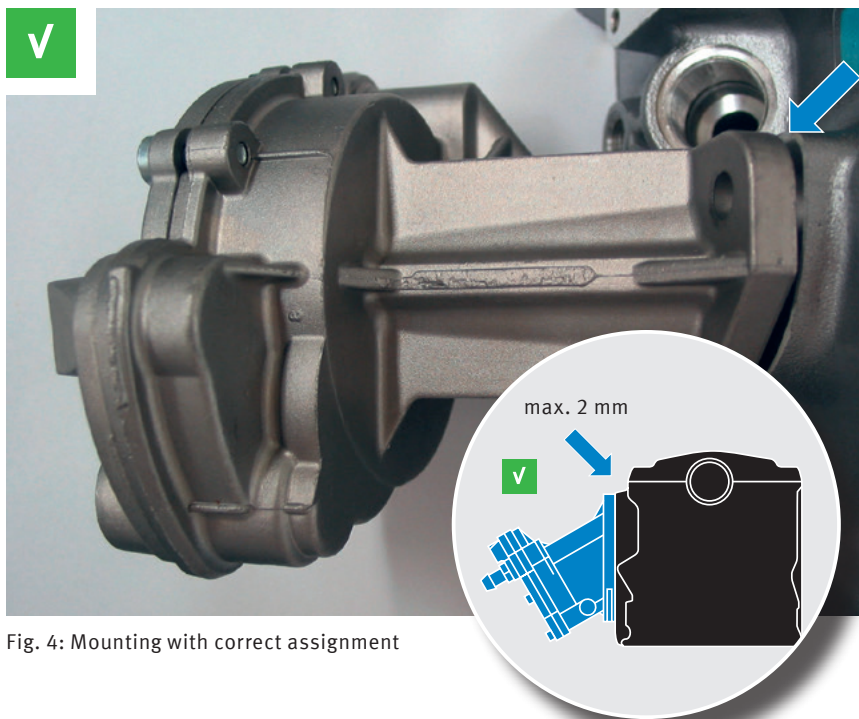
Fig. 4: Mounting with correct assignment

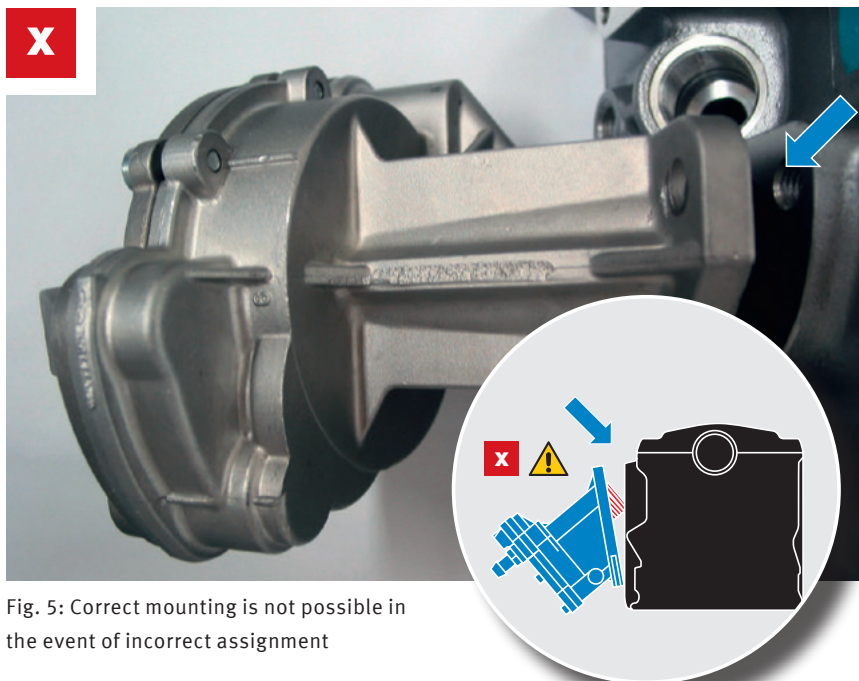
If it is not possible to press the vacuum pump to the flange (approx. 5 mm gap) without great effort, even with the cam on the opposite side of the connecting tappet, an incorrect assignment has very likely taken place.

Fig. 5: Correct mounting is not possible in the event of incorrect assignment

It is essential to check the chassis number, registration date and/or the part number of the old pump! Never attempt to solve this problem by modifying the connecting tappet (e.g. regrinding)!
