# Antriebsriemen & Kits

## Technische Information für die Werkstatt

Ausgabe 76 | Dezember 2025

### ERGÄNZENDER EINBAUHINWEIS

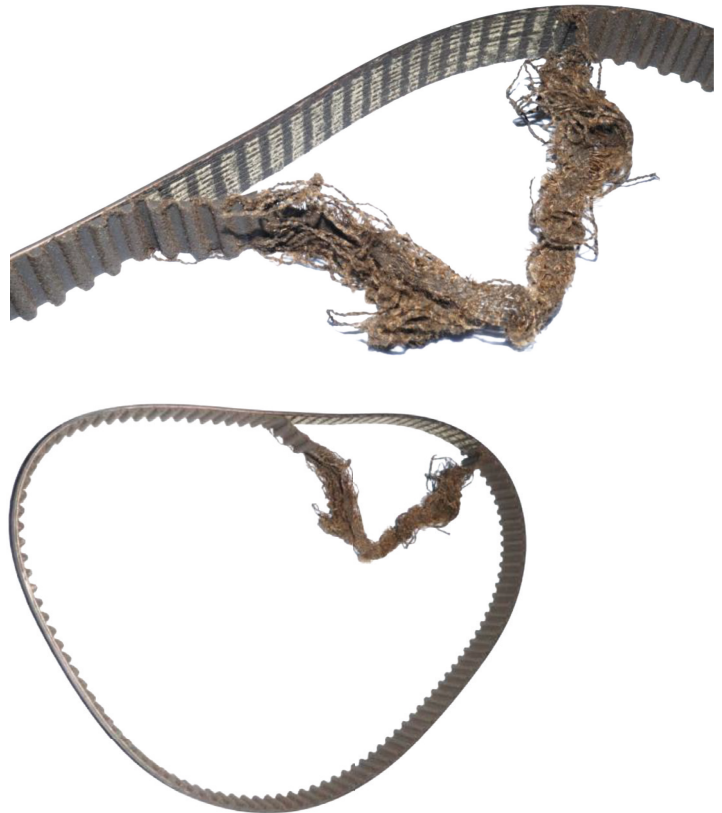
- Stark verschlissene oder fehlende Zähne in einem begrenzten Bereich des Zahnriemens.
- Ein verschobenes oder loses Flügelrad in der Wasserpumpe.

Die Spitzenbelastungen durch die Nockenwelle und die Hochdruckpumpe (HDP) sind nicht gleichmäßig verteilt, sondern auf einen Punkt konzentriert. Durch die dadurch entstehenden pulsierenden Lastspitzen werden einige Zähne des Riemens zerrieben und der Presssitz des WP-Flügelrades auf der Welle gelöst.

Je größer die Abweichung der HDP-Einstellung von der korrekten Position, desto früher kommt es zum Schaden und Ausfall des Riementriebs.

Bosch empfiehlt, unbedingt nach Abschluss der Arbeiten am Steuertrieb die Position der HDP zu prüfen und nach Angaben des Fahrzeugherstellers zu korrigieren.

- **Markierung am HDP-Antrieb fluchtet mit der Markierung am Gehäuse.**
- **Nockenwellenriemenscheibe ist abgesteckt auf HDP-Einbauposition (nicht OT).**

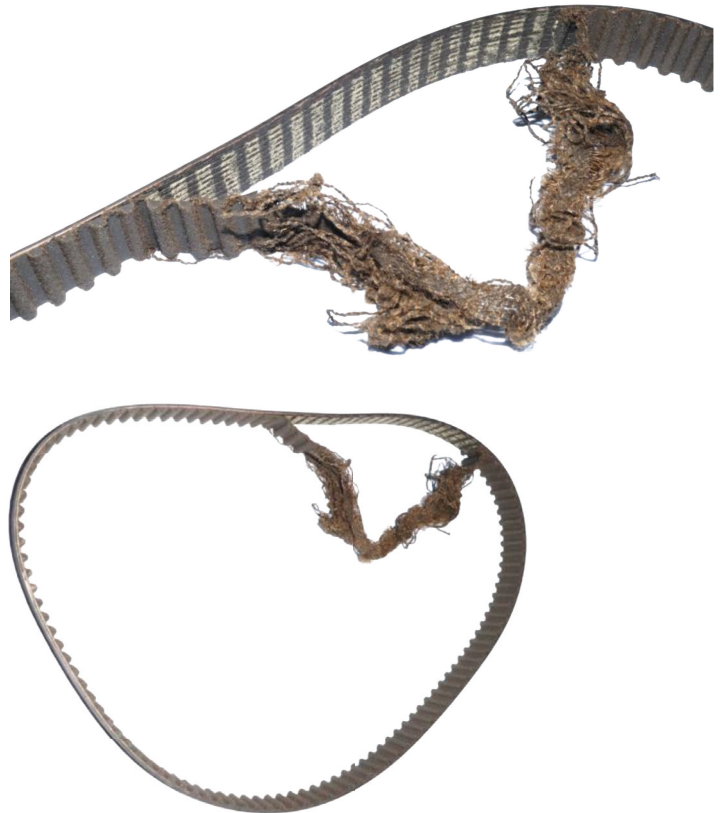
- Heavily worn or missing teeth in a limited area of the timing belt.
- A displaced or loose impeller in the water pump.

The peak loads from the camshaft and the high-pressure pump are not evenly distributed, but concentrated at a single point. The resulting pulsating load peaks cause some of the belt teeth to be worn down and the press fit of the WP vane wheel on the shaft to be loosened.

The greater the deviation of the HDP setting from the correct position, the sooner damage and failure of the belt drive will occur.

Bosch recommends always checking the position of the HDP after completing work on the timing drive and correcting it according to the vehicle manufacturer's specifications.

- The mark on the HDP drive is aligned with the mark on the housing.
- The camshaft pulley is pinned to the HDP installation position (not TDC).
