## Chain Tensioner

to fit  
Mercedes-Benz M271 engines

**SWAG No. 10 92 6751**  
OE No. 271 050 06 11

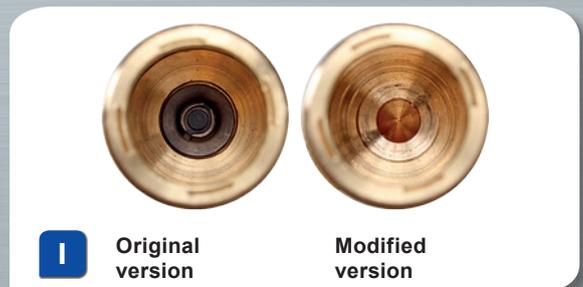
1

The manufacturer has modified the design of the chain tensioner. The version of the chain tensioner originally fitted (Repl. no. 271 050 04 11) has a non-return valve. In the new modified version (Repl. no. 271 050 06 11, the non-return valve has been removed (see Fig. 1).

Original version

Modified version

To prevent the problem described above, SWAG recommends that the bracket be replaced as well when the chain tensioner is exchanged for the new version. SWAG offers two kits (SWAG 10 94 0953 and SWAG 10 94 0954) which include the bracket with integrated nonreturn valve.

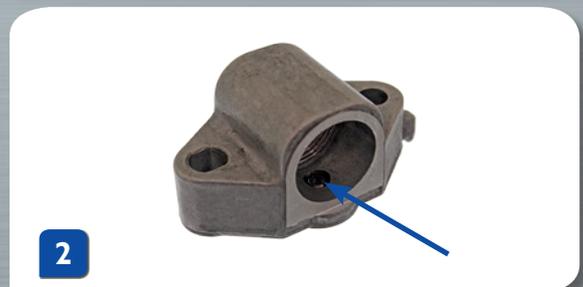
2

The chain tensioner is screwed into the bracket which incorporates a non-return valve (see Fig. 2). This valve controls the volume of oil so that the piston of the chain tensioner is constantly supported by the oil pressure should the oil pressure fluctuate.

If the non-return valve in the bracket does not work correctly, the oil is always able to flow back again. As a result, the chain tensioner cannot tension the chain correctly even though the chain tensioner has been refitted. This can lead to engine damage, especially when starting up and under heavy load.
