SERVICEINEORMATION

WATER PUMPS FROM AUDI/SEAT/ŠKODA/VW

DANGER OF BREAKAGE: NOTE DURING FITTING!

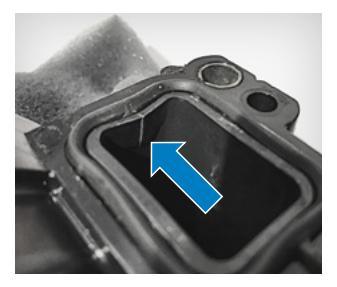
With the water pumps listed above, there is a danger that the housing may break in the event of incorrect installation. The loss of cooling output may result in severe consequential damage, e.g. engine damage.

- Gaskets are contaminated with oil, e.g. due to oiling of the gasket or engine oil contamination in the surrounding area. This can cause the gasket to swell and the housing to break (Fig. 2 and 3).
- The sequence of the screw connection and the tightening torques have not been complied with.

Fig. 2: Breakage (damage pattern)

- All gaskets of this water pump are exclusively designed for use with cooling liquid. They must never be oiled, e.g. with engine oil.
- The area around the installation location and the coolant agent must also be free from impurities.
- Contact with oil could cause the gaskets to swell in their groove, and the housing of the pump may break.
- Do not use additional sealant. The pump may develop leaks (Fig. 5).

Gaskets may be lubricated with cooling liquid to make mounting easier. Only use new sealing rings.

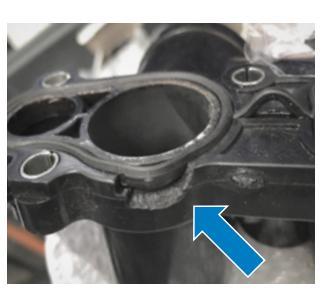
Fig. 3: Breakage (damage pattern)

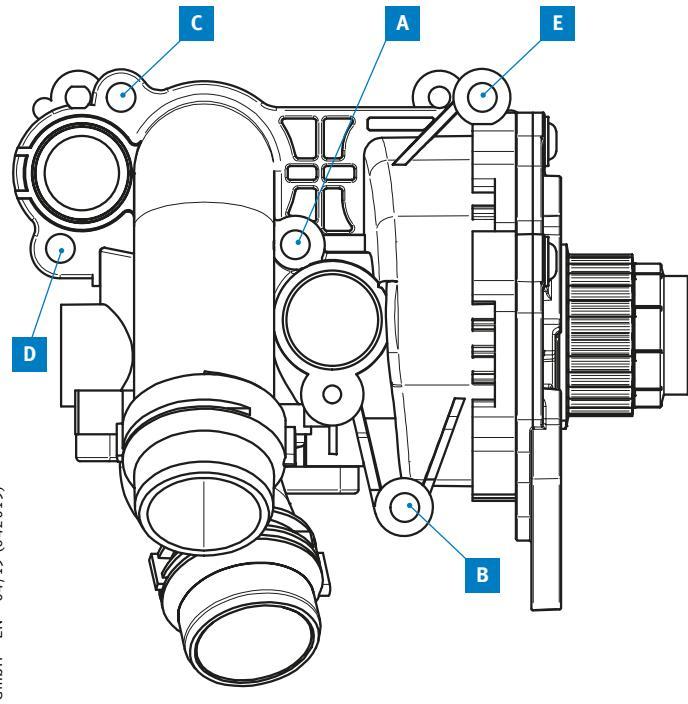
Fig. 4:

Sequence of the screw connection [A] – [B] – [C] – [D] – [E]

- The sequence for tightening the bolts must be followed (Fig. 4): [A] [B] [C] [D] [E]
- Tightening torque: 9 Nm
- Risk of injury:

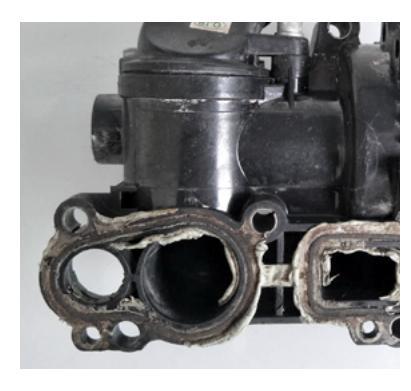
Fig. 5: Leakage due to additional sealant (damage symptoms)

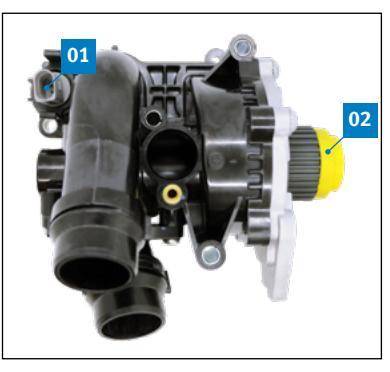
Fig. 6: 01 Temperature sensor* 02 Yellow protective cap**

Only remove yellow protective cap** (Fig. 6) on the ventilation wings after installation.
