Electric EGR valve (VAG 1.2 12 V)

Possible thermal damage

Vehicle	Product		Electric EGR valve
	PIERBURG No.	Replacement for	O.E. No.*
Seat Cordoba 1.2 12V Seat Ibiza 1.2 12V Skoda Fabia 1.2 12V VW Polo 1.2 12V	7.22785.16.0	7.22785.07.0/.12.0	03D 131 503 B/D

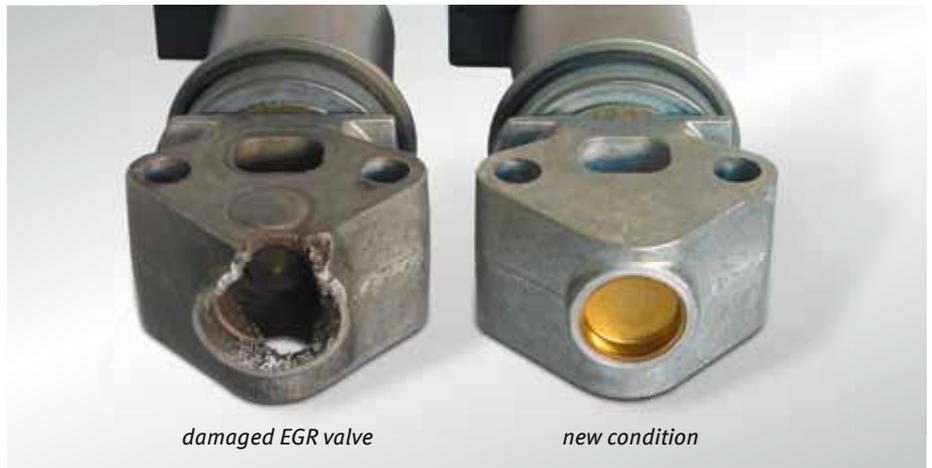
Through checks it has been found that the built-in electric EGR valves, in particular when travelling under full load, are exposed to increased thermal stress.

- The blind plug at the valve body develops a leak or is lost. Exhaust gas escapes.
- The valve is subject to deformation and will not fully close.
- In extreme cases the valve flange may be damaged by melting.

The causes for this can generally not be attributed to the EGR valve.

damaged EGR valve

new condition

When replacing the EGR valve we urgently recommend to check the software revision of the engine controller:

- **Engine Data revision level (minimum)**
- BME 7000/7001**
- AZQ 5323 - 5329**
