TROUBLE TRACER – LININGS

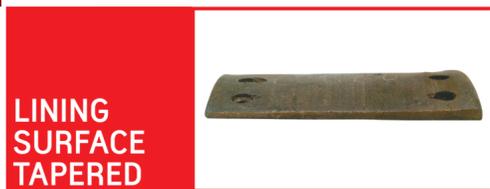
LINING SURFACE TAPERED

- Brake shoes misaligned with the brake drum
- Distorted brake shoe or brake drum turned on taper

- The linings may lock on to the drum when braking from high speeds
- Vehicle pull and excessive brake noise may occur

SOLUTION Replace or grind/machine drum. Replace brake shoe anchor pins or parts that locate brake shoes

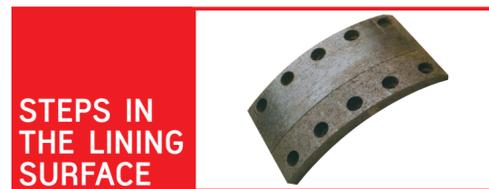
STEPS IN THE LINING SURFACE

- There may be a step in the brake drum surface
- General drum wear

- Rapid lining wear
- If the wear pattern differs across the axle, vehicle pull and excessive noise can result

SOLUTION Grind/Machine drum surface or renew (a drum grind may incur oversize lining fitment)

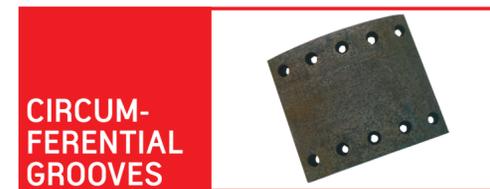
CIRCUMFERENTIAL GROOVES

- Poor drum condition
- Improper preparation with a wire brush, shoe grinder or similar

- Vehicle pull may occur if there is a different wear pattern on the opposite axle end
- Insufficient deceleration and excessive noise

SOLUTION Replace linings and grind or replace drum as appropriate

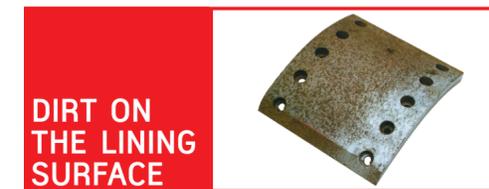
DIRT ON THE LINING SURFACE

- Dirt particles in the brake
- Poor brake maintenance (insufficient cleaning)

- High lining and drum wear
- Poor deceleration
- Vehicle pull and excessive brake noise may occur

SOLUTION If heavy contamination, replace linings and ensure contamination-free relining operation

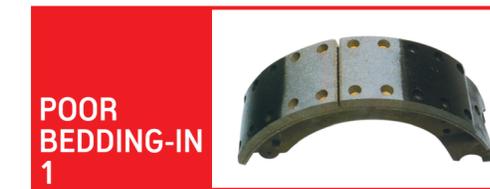
POOR BEDDING-IN 1

- Lining radius is larger than actual drum diameter
- Bedding-in period for the lining was too short

- Vehicle pull and excessive brake noise may occur
- Low deceleration

SOLUTION Replace linings and ensure the correct lining radius to drum diameter is selected, or extend bedding-in period

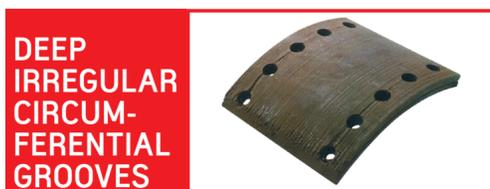
DEEP IRREGULAR CIRCUMFERENTIAL GROOVES

- Large particles loose in the brake
- Very poor drum condition and maintenance

- Very high lining and drum wear
- Squeal

SOLUTION Avoid contamination. Replace linings and grind or replace drum as appropriate.

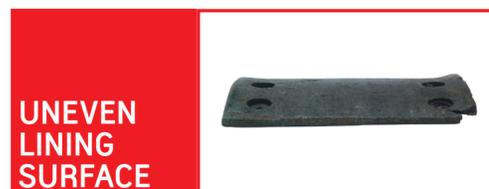
UNEVEN LINING SURFACE

- Wrongly adjusted or worn axle bearings

- Very high lining and drum wear
- Squeal

SOLUTION Replace linings, replace wheel bearing and replace or grind drum as appropriate

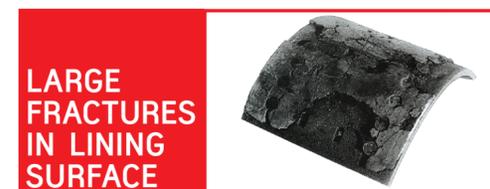
LARGE FRACTURES IN LINING SURFACE

- Faults in brake mechanism
- Sticking brake shoes (weak return springs)
- Excessive use of brakes at high speed
- Overloaded vehicle
- Too large air chambers

- High lining wear
- Vehicle pull and excessive brake noise
- Disintegration of lining
- Low deceleration

SOLUTION Replace linings, avoid overworking brakes and ensure brake components are correct and are in good condition

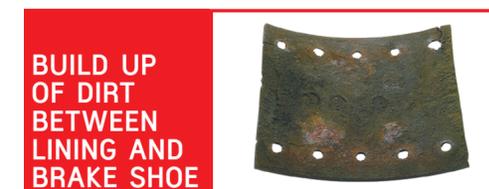
BUILD UP OF DIRT BETWEEN LINING AND BRAKE SHOE

- Shoe radius out of line
- Shoe platform not blast cleaned and painted properly
- Shoe platform not parallel
- Lining riveted incorrectly

- Cracks in the lining material or crack in drum surface
- Loose linings
- Squeal
- Improper cleaning causes rust scale to build up and lift the lining from the shoe

SOLUTION Replace linings and ensure shoe is clean and free from contamination before lining fitment

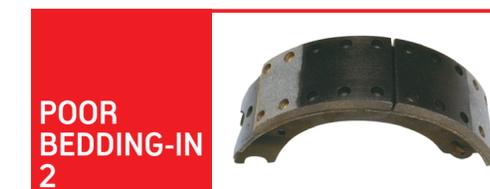
POOR BEDDING-IN 2

- Drum diameter is larger than lining radius
- Bedding-in period for the lining was too short
- Drum wear

- If the wear pattern differs across the axle, vehicle pull can result; also excessive brake noise
- Low deceleration

SOLUTION Replace linings and ensure the correct lining radius to drum diameter is selected, or extend bedding-in period

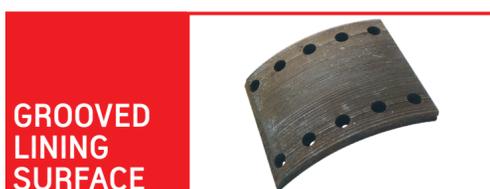
GROOVED LINING SURFACE

- Small loose particles in the brake
- Insufficient drum cleaning at replacement

- Very high lining and drum wear
- Squeal

SOLUTION Replace linings and avoid brake operation in dusty environment. Grind or replace drum as appropriate

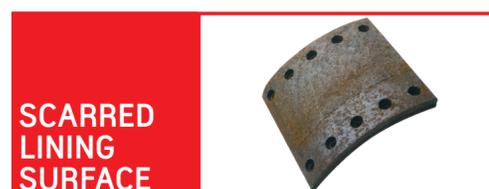
SCARRED LINING SURFACE

- Poor drum condition, e.g. heat crazing

- Rapid lining wear
- If linings not 100% bedded-in, low brake efficiency can result

SOLUTION Replace linings and avoid overheating brakes

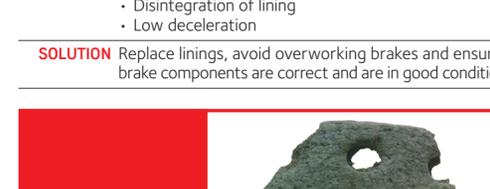
BURNT LINING SURFACE

- Faults in brake mechanism
- Sticking brake shoes (weak return springs)
- Excessive use of brakes from high speed
- Wrong brake cylinders/air chambers or levers
- Overloaded vehicle
- Incorrect brake proportioning between tractor/trailer units

- High lining wear
- Vehicle pull and excessive brake noise
- Deceleration too low

SOLUTION Replace linings, avoid overworking brakes and ensure brake components are correct and are in good condition

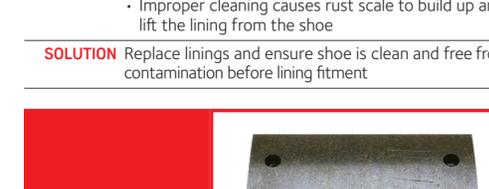
SURFACE CRAZING

- Caused by excessive brake temperature, i.e. when brake is cold on motorway then having to perform a sudden stop i.e. off a slip road. Rapid temperature input does not allow for heat soak from material into brake system

- This condition has no effect on the integrity or performance of the lining
- Penetration of the crazing is usually no more than 1mm deep
- Wear through with normal brake use and has no effect on the lining

SOLUTION Avoid high-speed heavy duty braking from cold

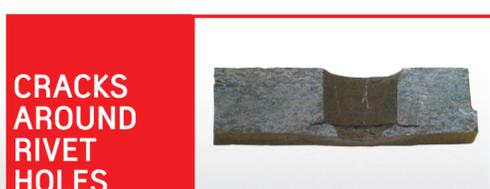
CRACKS AROUND RIVET HOLES

- Too heavy riveting force
- Wrong shape of rivet heads
- Brake shoe radius does not conform to lining radius
- Brake shoe platform is not clean or even

- Lining and drum breakage
- Brake over-heating
- Noise

SOLUTION Replace linings, and avoid excessive pressure during riveting operations

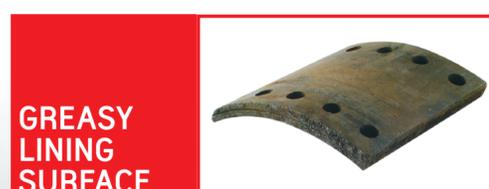
GREASY LINING SURFACE

- Broken or improperly mounted hub oil seals
- Excessive lubrication of the bearings of the braking mechanism

- Vehicle pull may occur if the problem is only found at one side of the axle
- Low deceleration

SOLUTION Remove grease from the linings, cure oil/grease leaks
