30 94 5956 30 10 2196, 30 10 2426, 30 10 6512, 30 10 6513, 33 10 1100, 33 10 1123

to fit: Volkswagen, Audi, Seat & Skoda various models

Timing Chain Kit and Camshaft Bracket

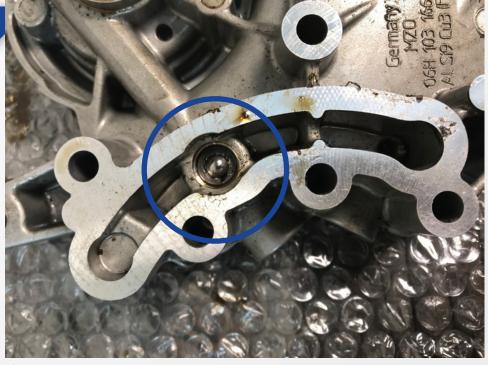
Figure 1

If the data is reading over 5 degrees at idle or during a snap wide open throttle test then the screen for the oil non return valve, located in the camshaft adjuster bracket has come apart and lodged itself within the camshaft adjuster spool valve and the intake camshaft adjuster (Fig 1).

If the oil screen is present and the mechanical timing is correct, inspect the intake camshaft spool valve, for damage or if the end of the valve has come apart, resulting in a portion of the spool valve being left in the adjuster bore.

Replace the timing chain kit, camshaft adjuster bracket, intake camshaft and the spool valve adjuster.

Follow the vehicle manufacturer's procedures during the inspection and replacement. It is recommended to replace the engine oil and filter as part of the repair.
