Service Information XZS125

## GDB1542/1599 with two different warning cables

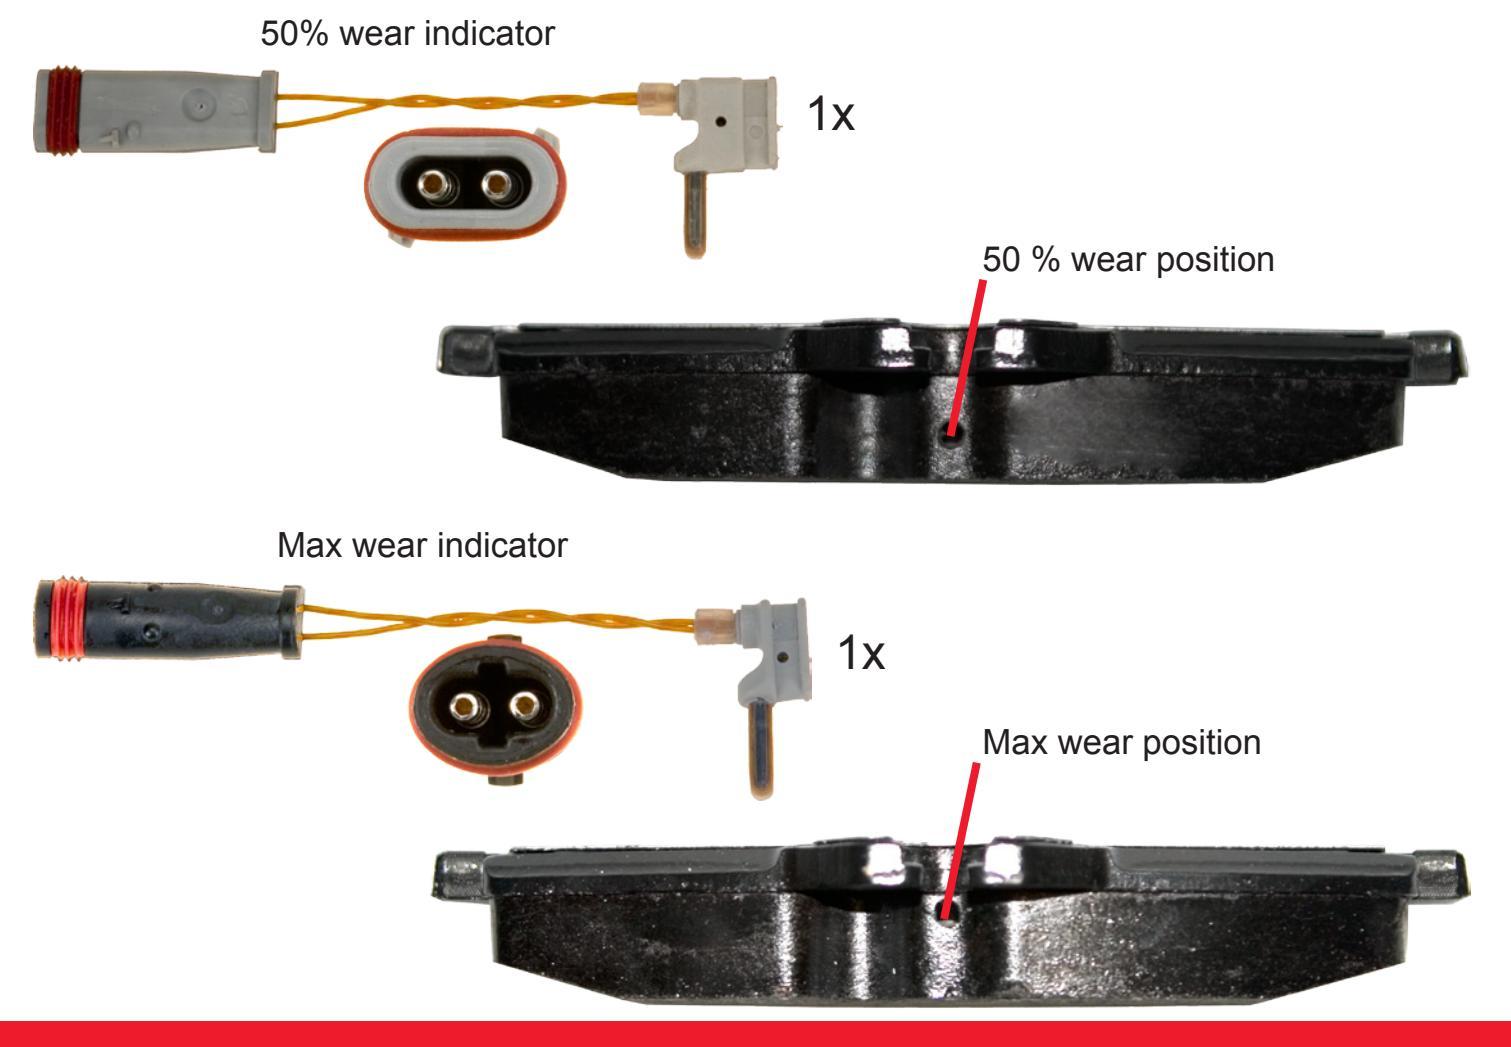
In the box of GDB1542/1599 you will find two types of wear indicator cables and two pads with holes drilled in different locations to accommodate them.

One pad has a hole which is for 50% wear indication. If the disc is in contact with the sensor, the pad wear reached 50%. This information will be stored in the ECU. The driver will not receive an indication.

The other drilled pad has a hole for maximum wear indication. When this indicator senses that the pad is at the preset maximum wear, a warning light in the vehicle is illuminated constantly. The pads will then need to be changed.

Note: the indicators have different plugs to prevent them being connected incorrectly.
