Technical development of clutch discs has led to the linings on some models being attached by adhesives. The modified procedures mean that some of the rivet holes are now empty.

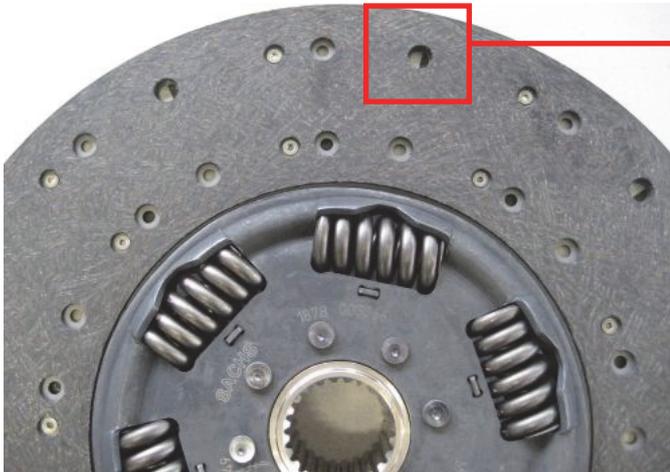
Fig. 1: Lining on the engine side

The engine side of the lining (Fig. 1) is bonded directly onto the rigid driving panel.

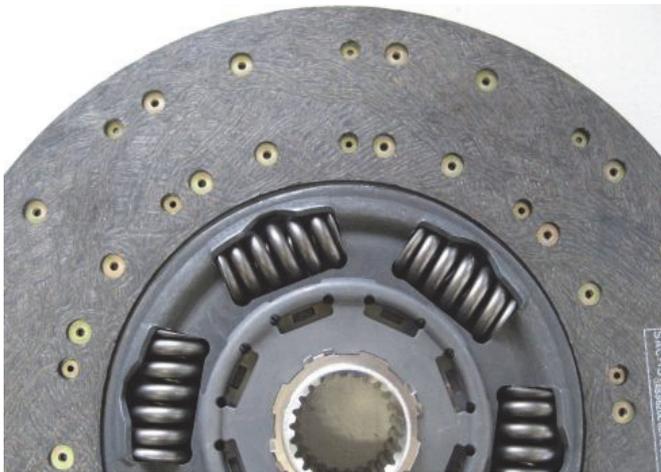
Fig. 3: Lining on the gearbox side

The gearbox side of the lining (Fig. 3) is first bonded to a carrier panel.

The lining springs are then riveted to the carrier panel.

And then the lining springs are riveted to the driving panel.
